Report On Phase One Conservation–Restoration

Prepared by John Osborne ACRA, DTT, FSG, May 2009

Images showing the Cleaning; Appendix “B”

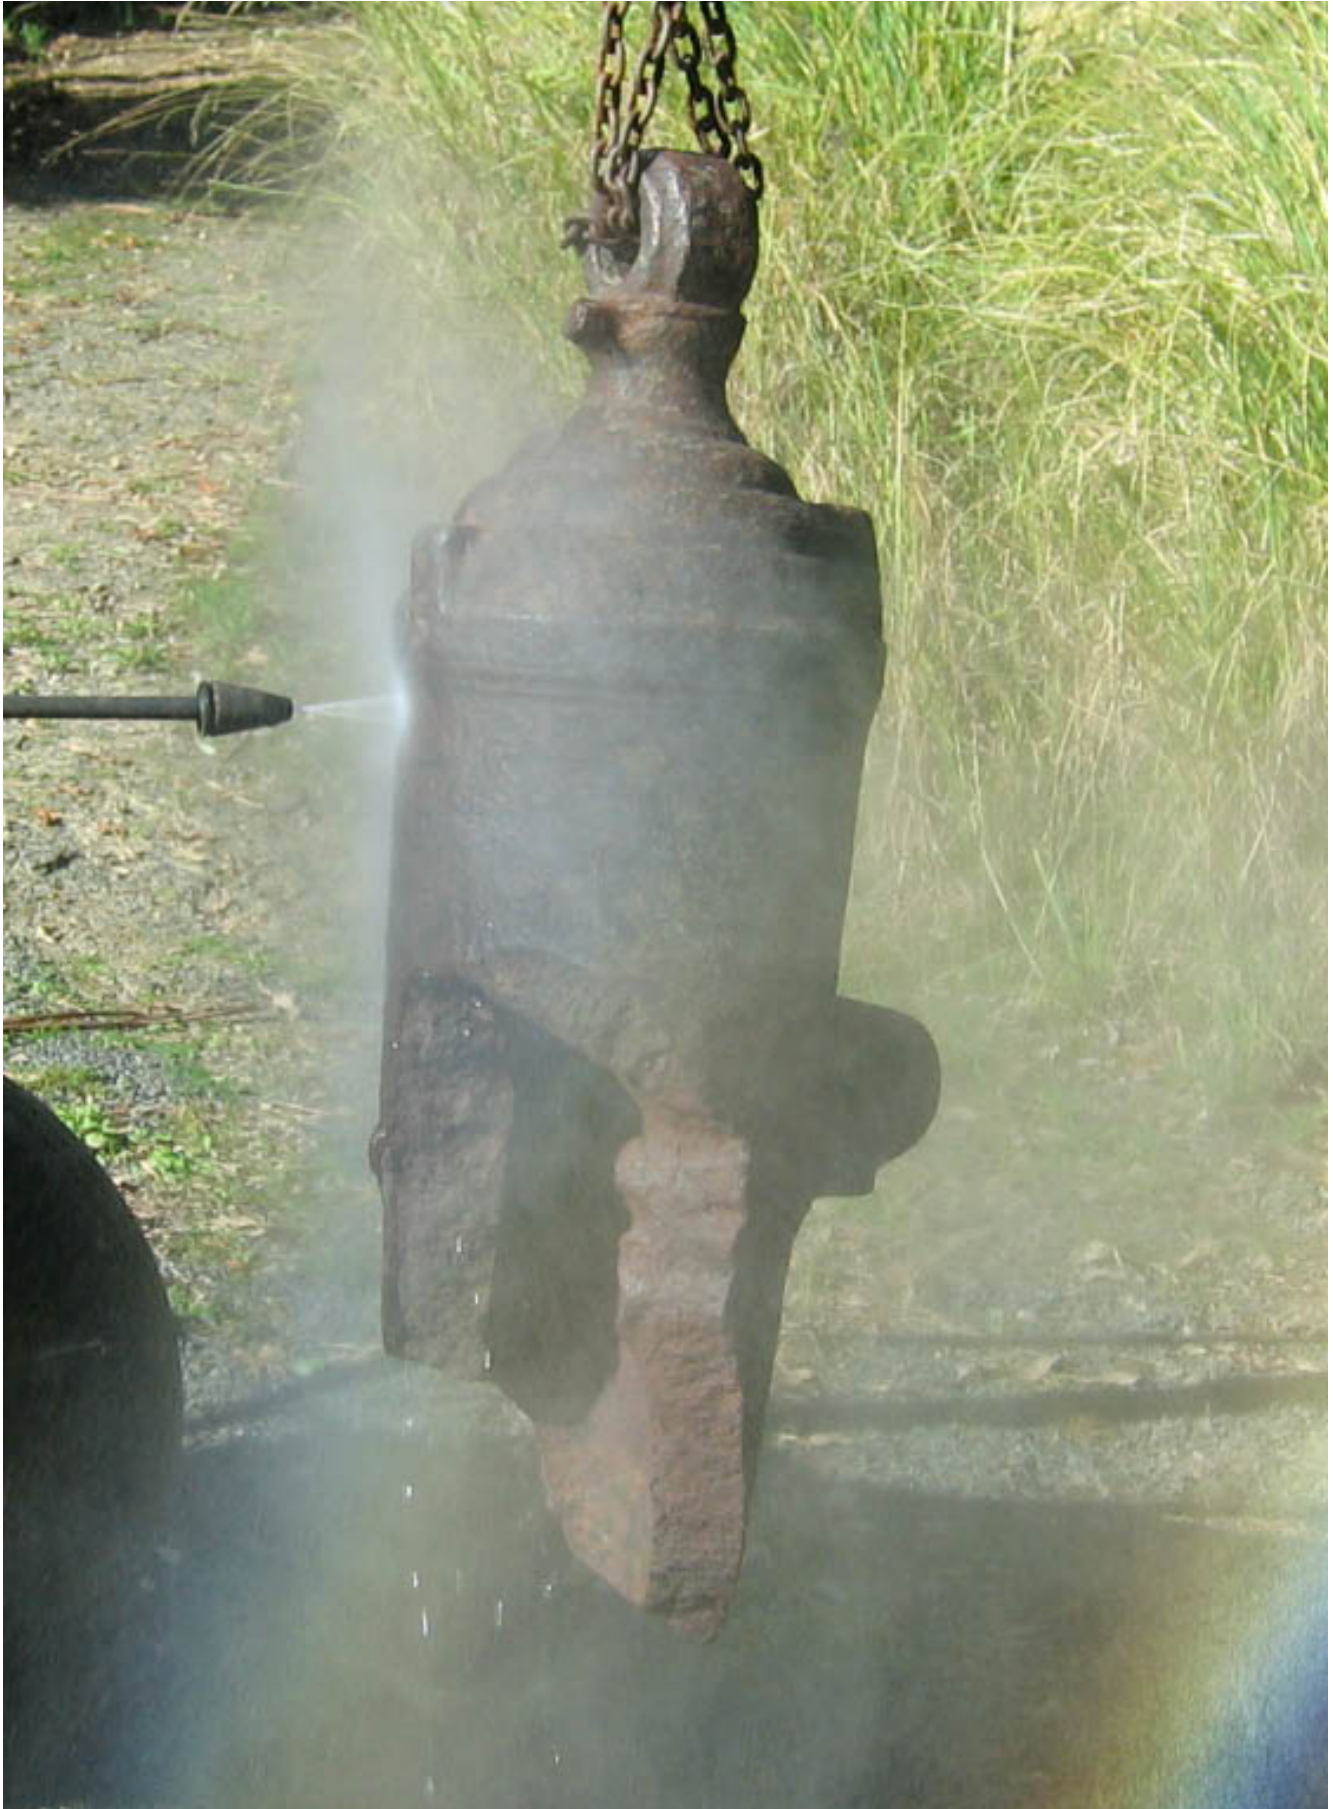
Water blasting using a turbo nozzle, this process was repeated several times to dislodge surface rust and growths.

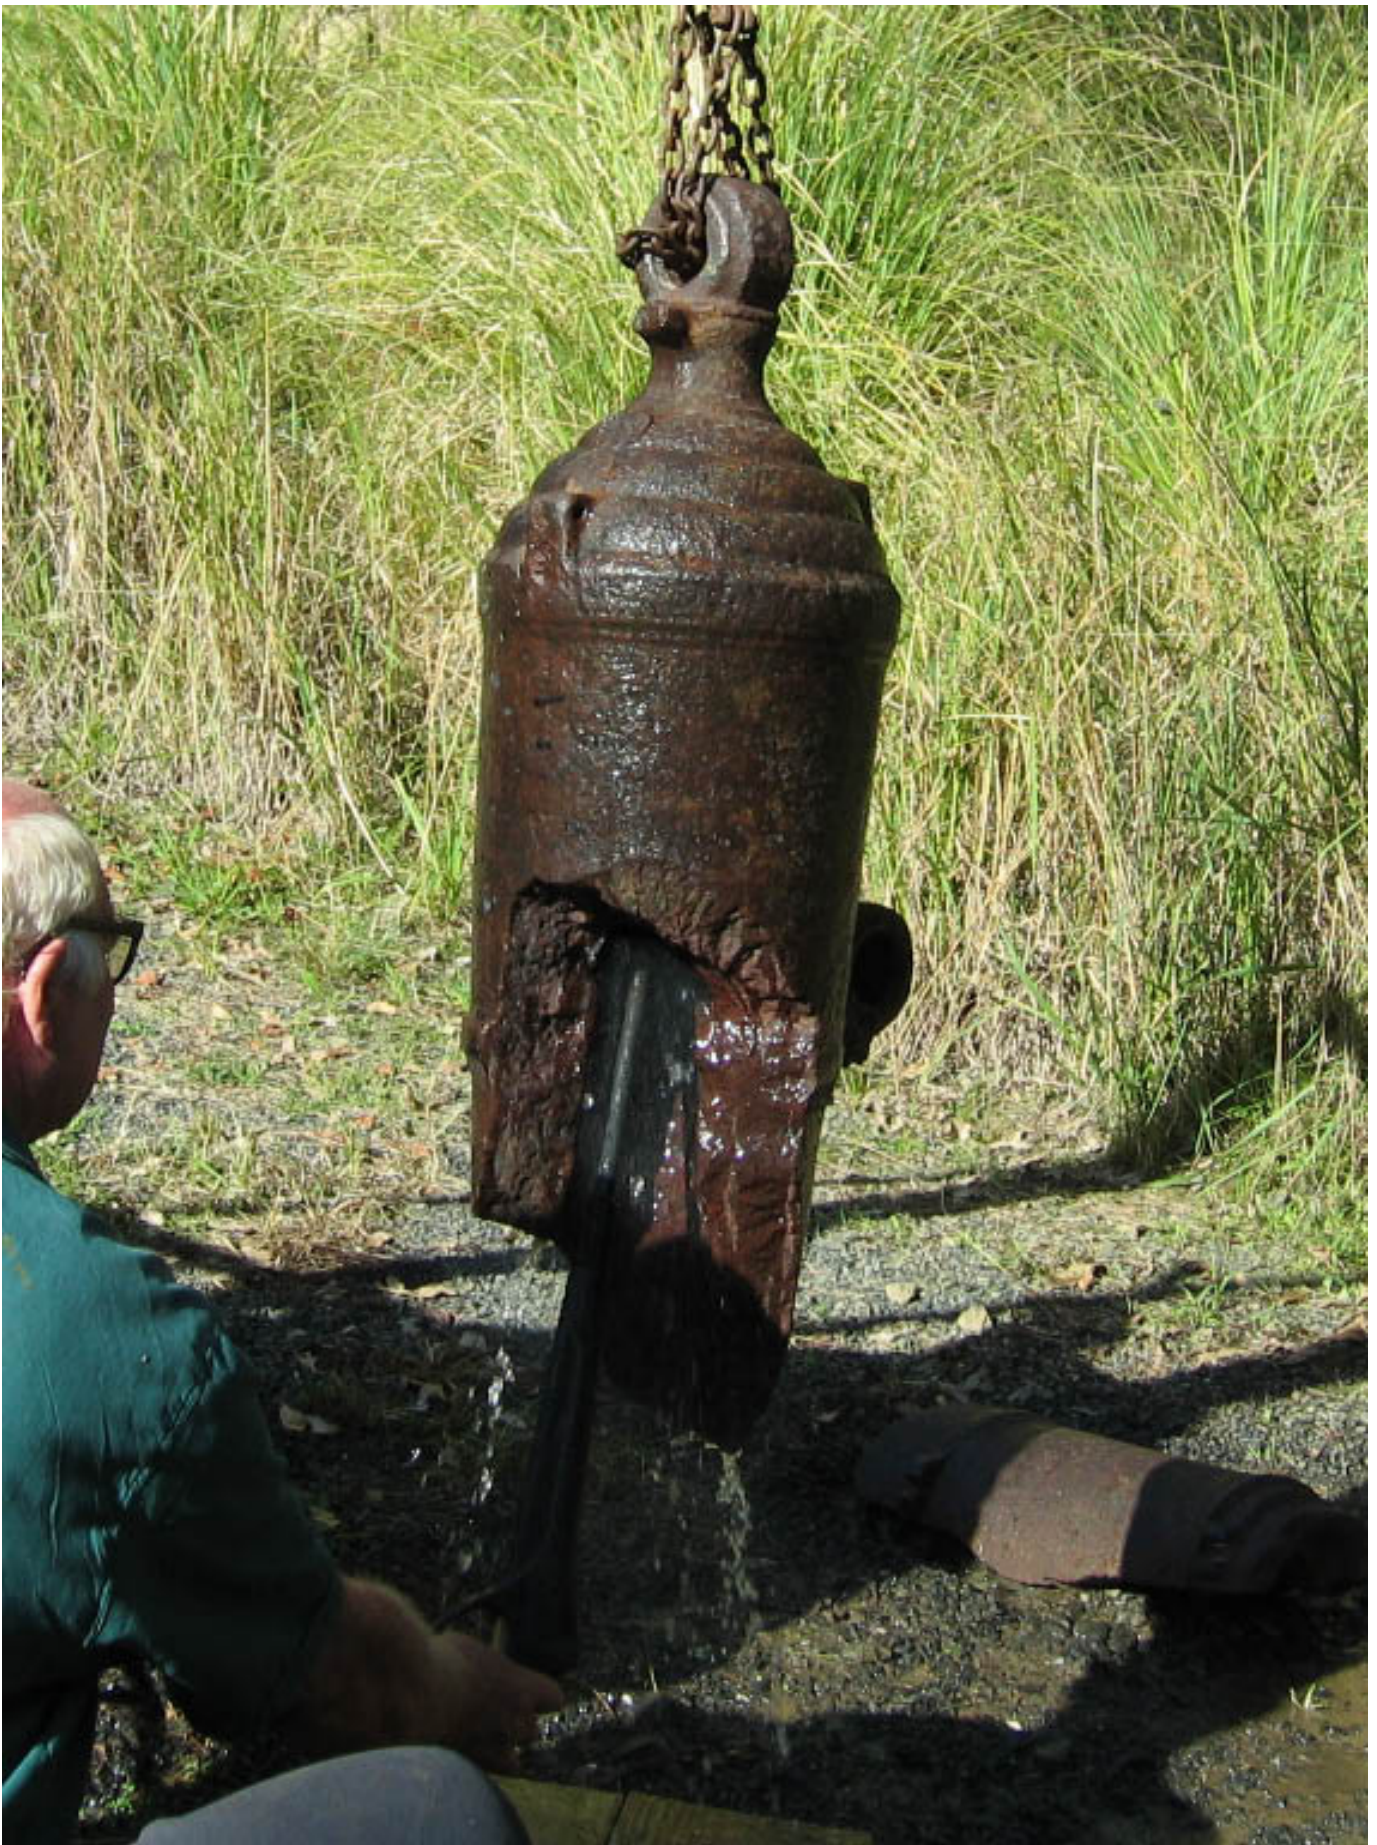
Water blasting the bore and ball using a turbo nozzle, this process was repeated several times to dislodge surface rust.

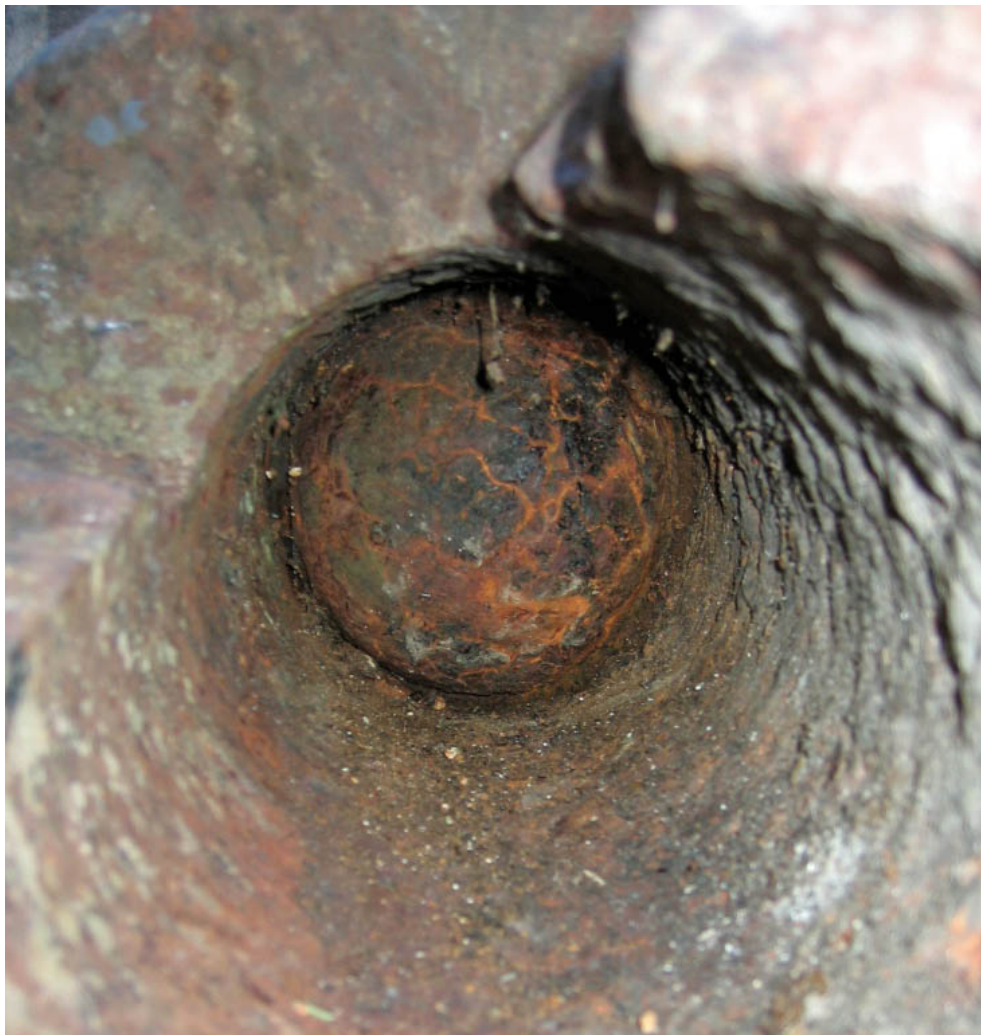
Image showing bore and outer face of ball as received.

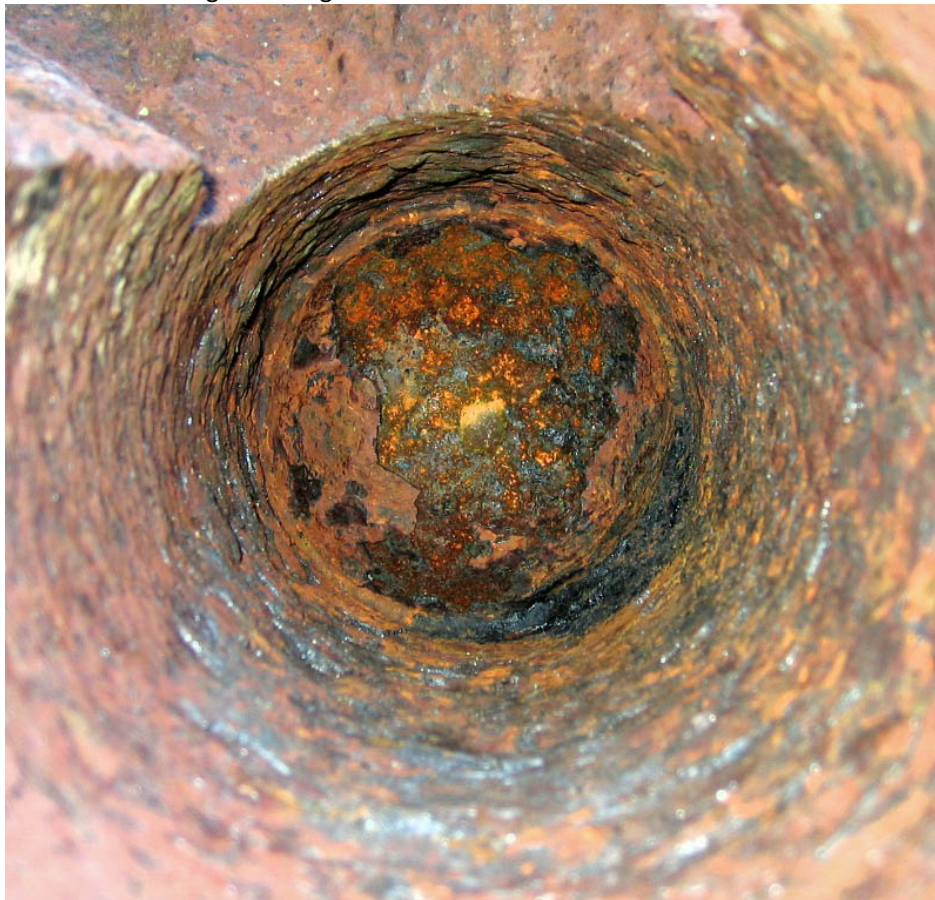
Image showing bore and outer face of ball after water blasting and scraping loose rust from bore. Ball was later removed.

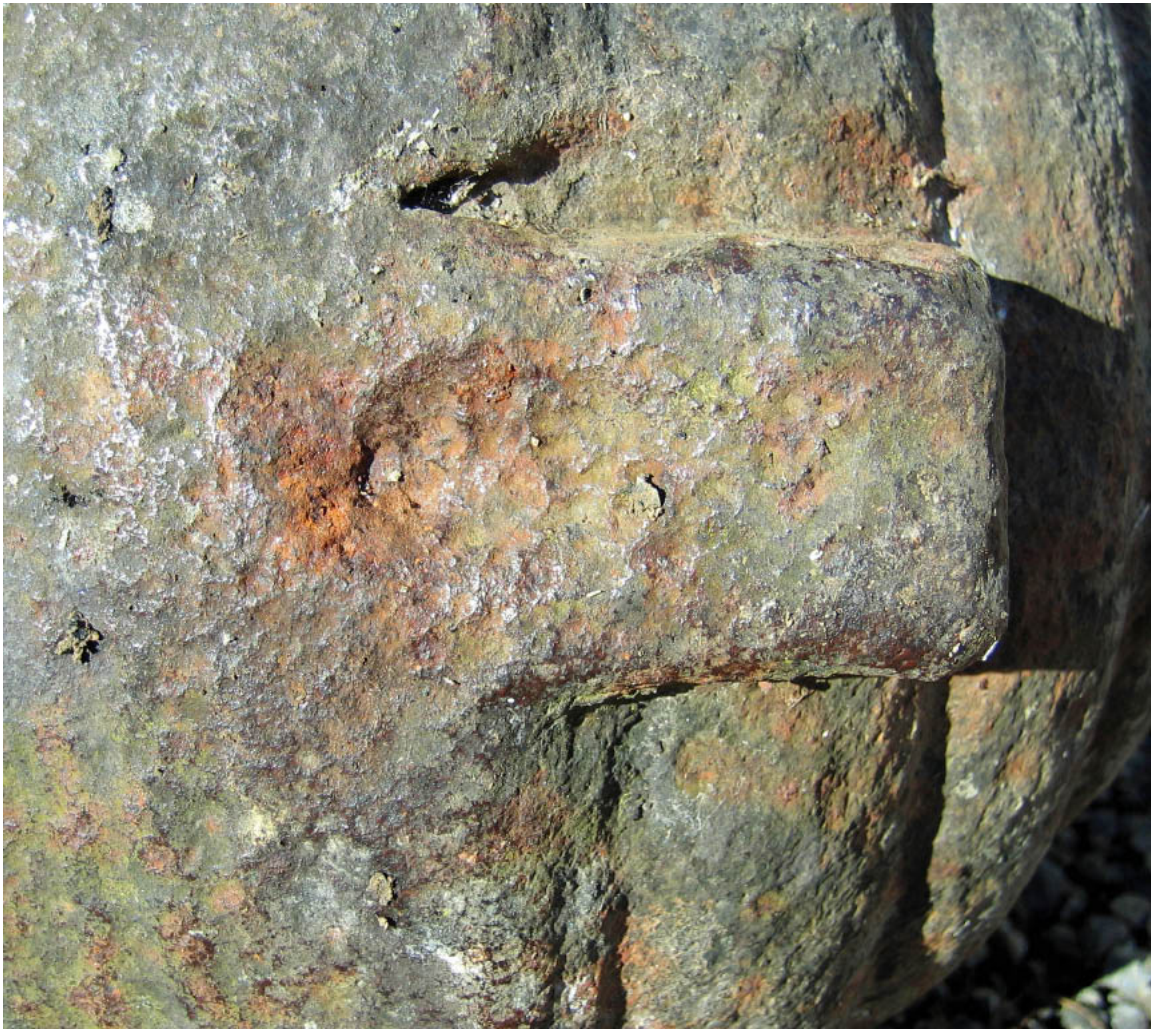
Condition of outer surface as received with surface growths and rusting. Vent hole blocked / peened over.

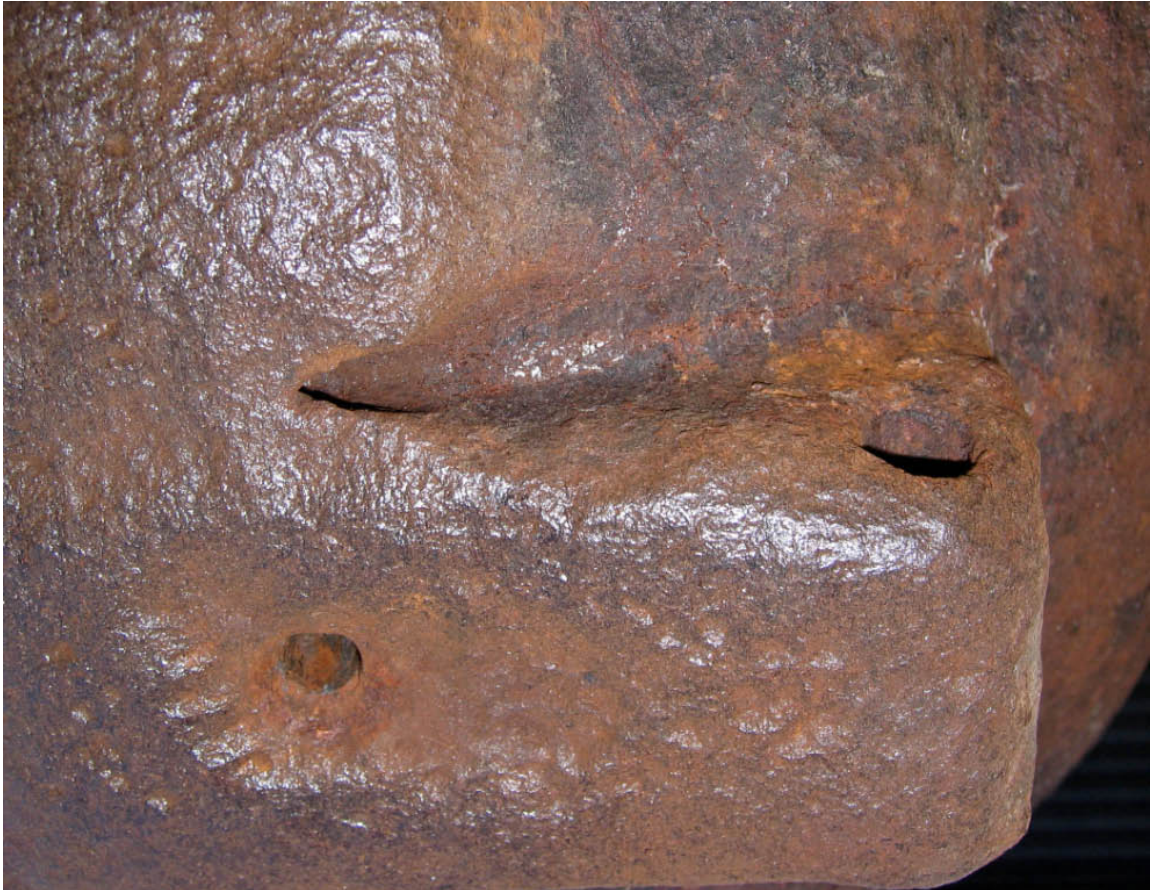
After water blasting and wire brushing (shiny areas) and vent hole drilled out. Flintlock igniter forward location (vee hole at top) and rear locking pin hole at rear of vent lump clearly visible.

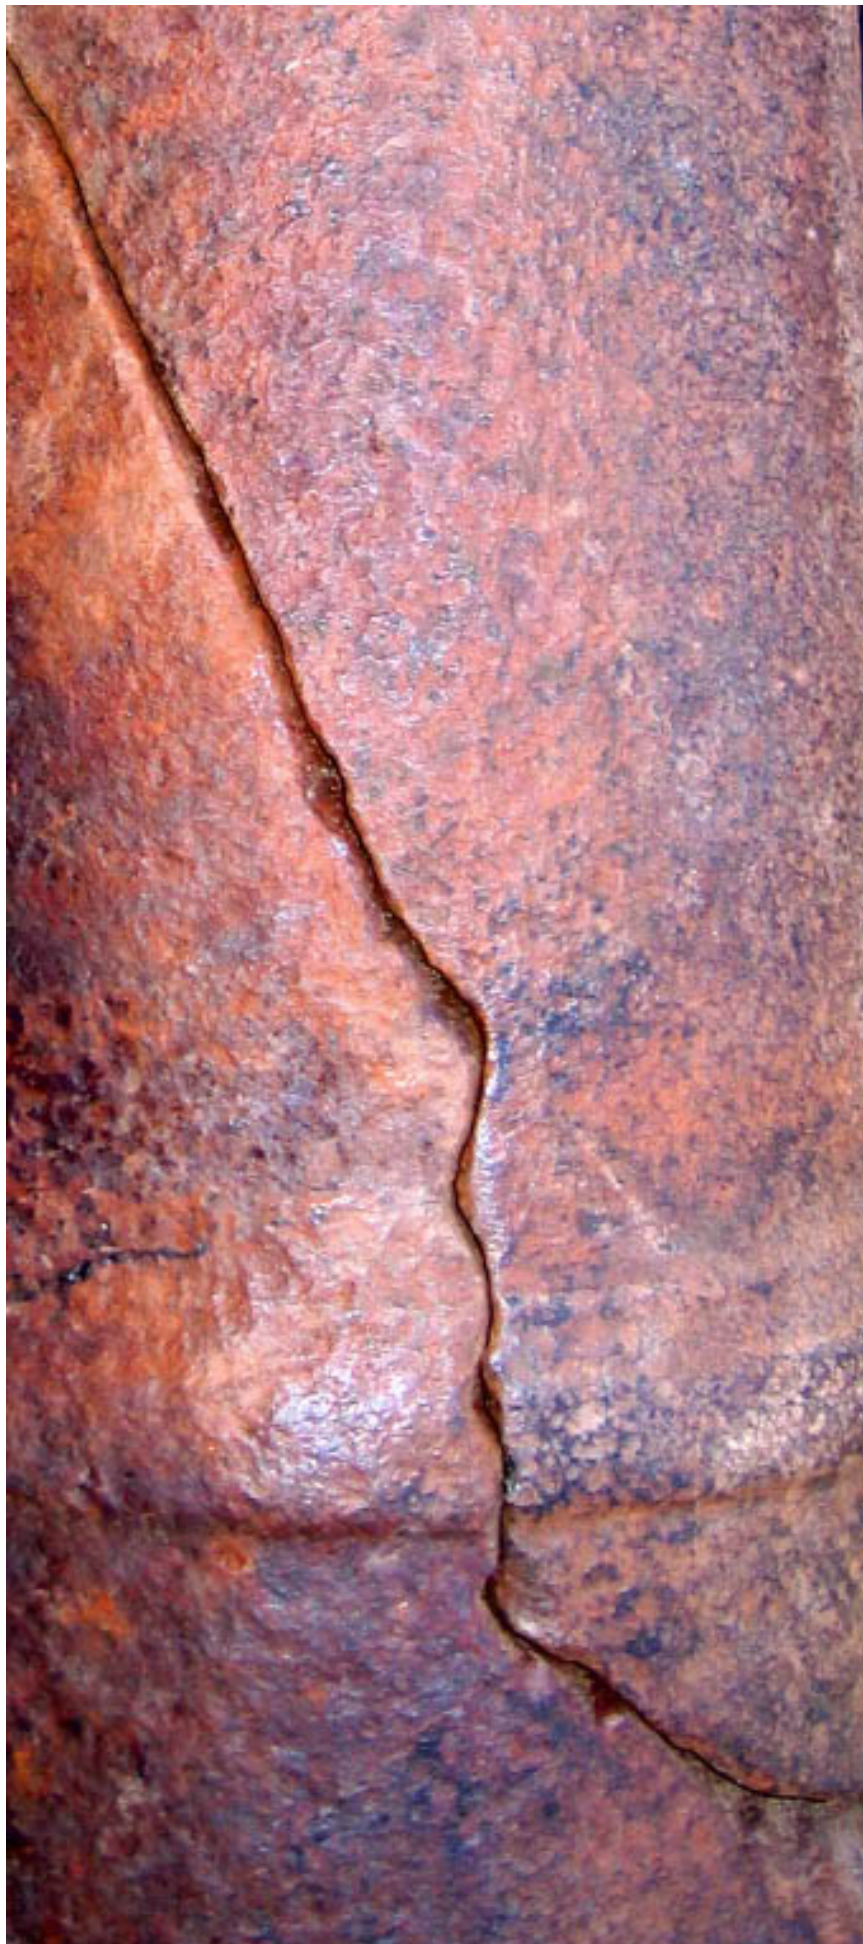
After water blasting and wire brushing - area showing the mating of the two broken barrel parts.
Traces of the black surface coating applied c1955 still showing.
