# Report On Phase One Conservation–Restoration

Prepared by John Osborne ACRA, DTT, FSG, May 2009

## Appendix “C”

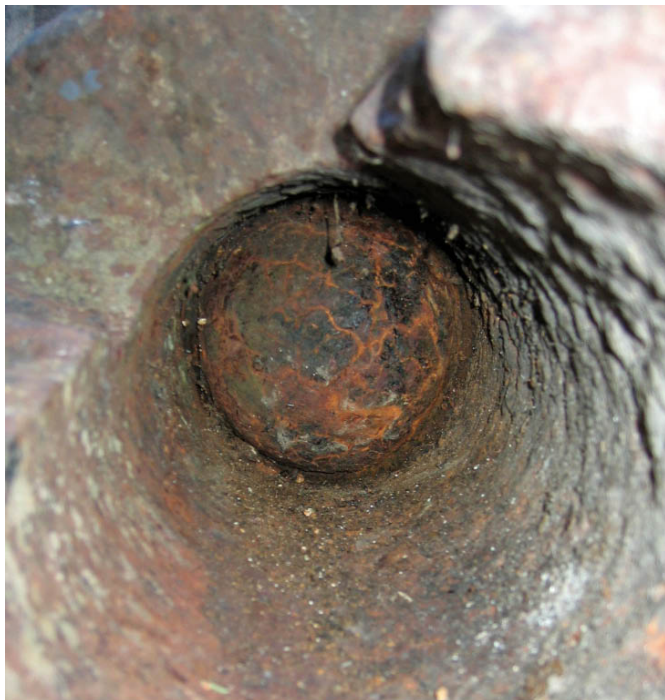
Image of bore and ball as received.

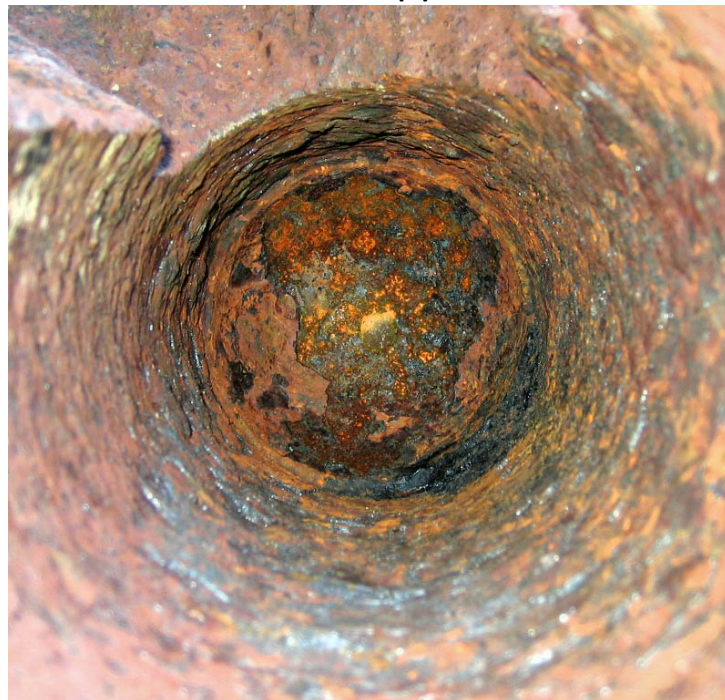
After water blasting and scraping bore to remove expanded rust

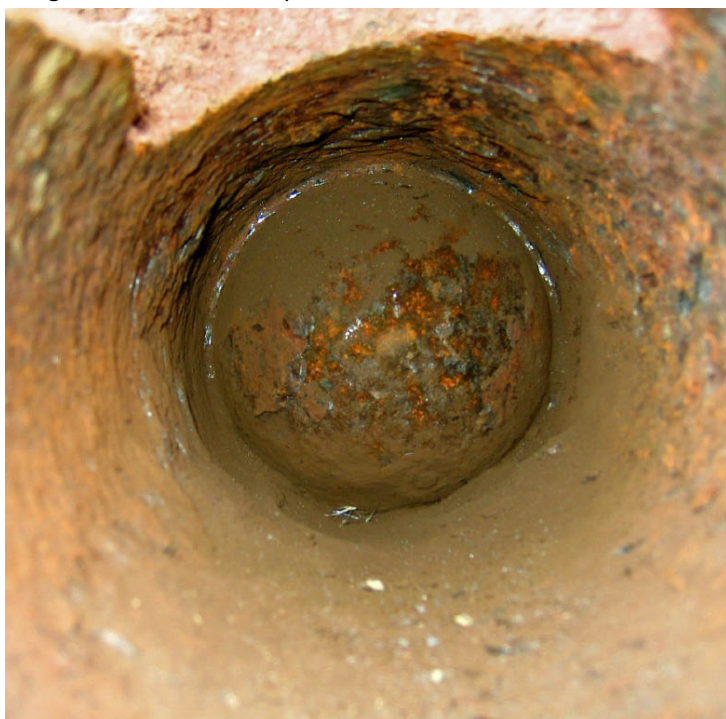
Rust dust from scraping between ball and bore.

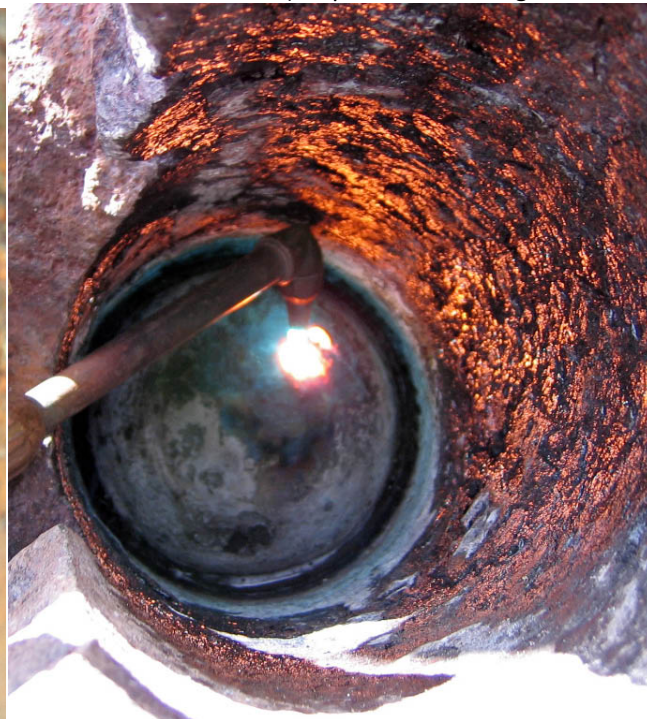
Flame heating the ball for over one hour.

to loosen the ball. Because the barrel was presumed to be loaded with powder, flame heating the ball was unsafe. To neutralise the possibility of igniting the powder the position of the vent hole was located and the spiked / blocked vent hole drilled / cleaned out, a very difficult process using a specially made long drill bit. The chamber was found to be dry with some traces of powder being removed on the drill bit. The powder chamber was filled with water from the nozzle of a water blaster, followed by the chamber being pressurised with compressed air (140 lbs/sq") and the bore filled with water to check if there was any possibility of the air pressure blowing the ball forward or air leakage passing between the bore and the ball, no movement or leakage detected. After placing the bore muzzle facing into a clay bank (in case the remaining powder charge was ignited blowing the ball out) an oxy-acetelene torch was fixed in position and used to heat the ball for over one hour, the heat being transferred from the ball through the rusted contact area to the barrel which was too hot to touch. Cold water was poured onto the ball which contracted the ball and boiled the water. The boiling water created mechanical agitation between the ball and barrel powder chamber chamfer loosening the rust holding the ball to the barrel. After a few strikes with the heavy tube rammer (whilst the water was still boiling) followed by the wedging action of the chisel end of the crow bar rammed down between the ball and bore the ball came loose and while still hot was removed.

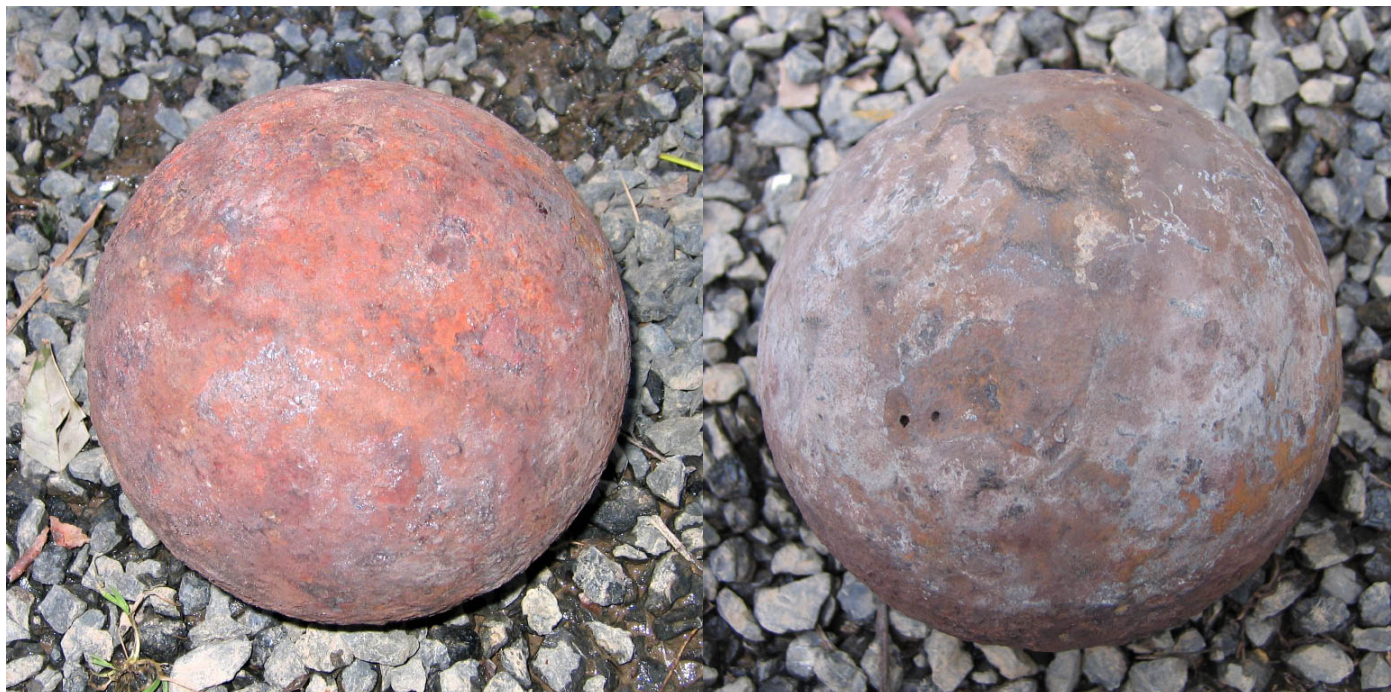
Left image: Ball as removed (still hot) showing side facing powder chamber. Compared to right image: outer side (rust flaked off) with bore / chamfer contact join line (lower) and showing small casting imperfections (holes). The standard nominal ball diameter c1800 for an 18 pounder was 5.04". This ball measured 5.08" maximum diameter includes light surface rust.

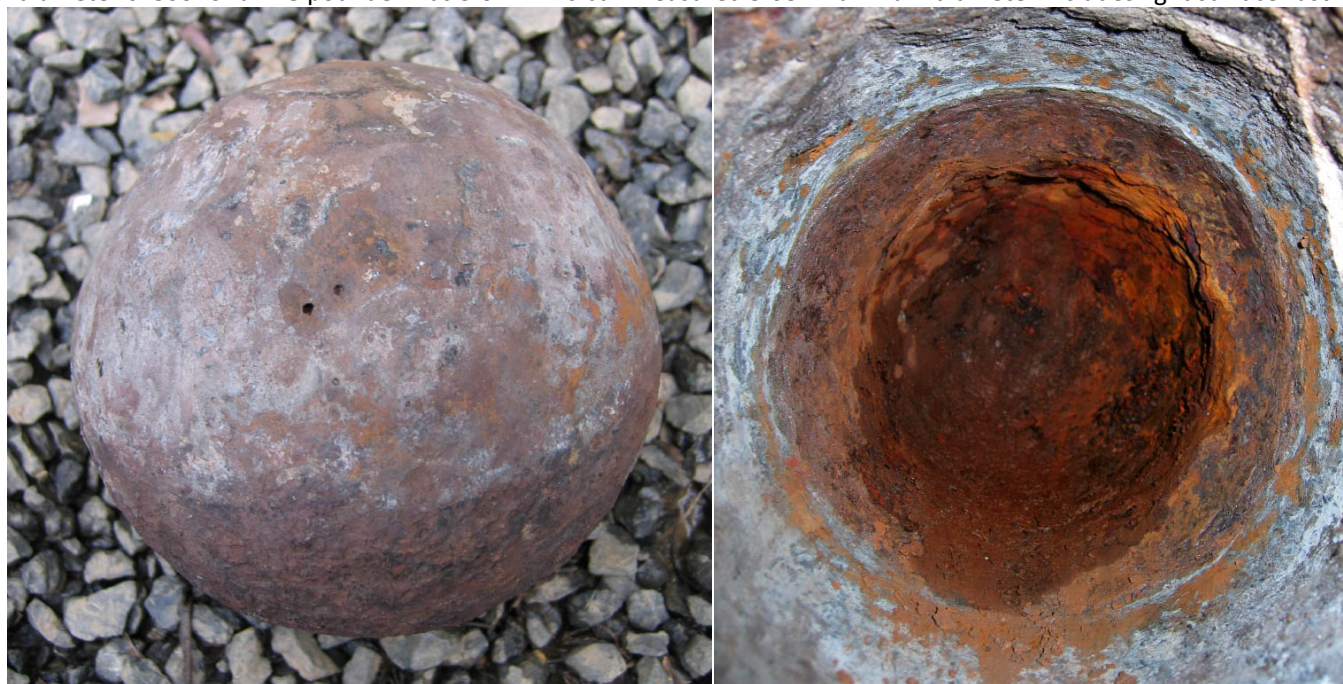
Left image: outer side (rust flaked off) with bore / chamfer contact join line and showing small casting imperfections (holes). Right image: showing the wide ball / chamfer contact area and the reduced diameter of the powder chamber still wet, since cleaned out.
